FOOTPATHS IN MOTTISFONT PARISH

Mottisfont Parish Council is investigating replacement of stiles on the public footpaths across the parish. The objective of such a project would be to improve accessibility by removing unnecessary stiles, or replacing stiles with suitable gates. This would have the additional advantage of removing stiles that are unsafe.

This report shows the routes of all registered footpaths in the parish, and identifies stiles and gates that have been found on those footpaths. It also suggests actions at each location.

Prepared by
Julia Barnett and Peter Barnett
February 2022

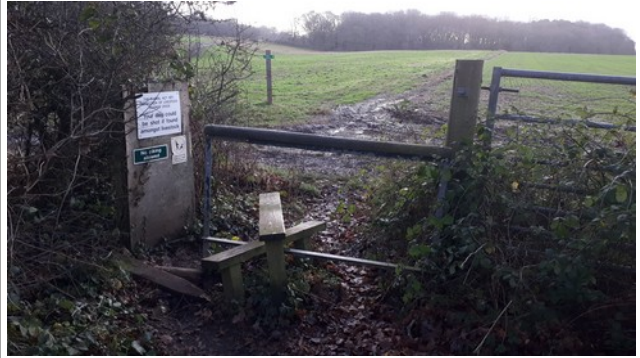
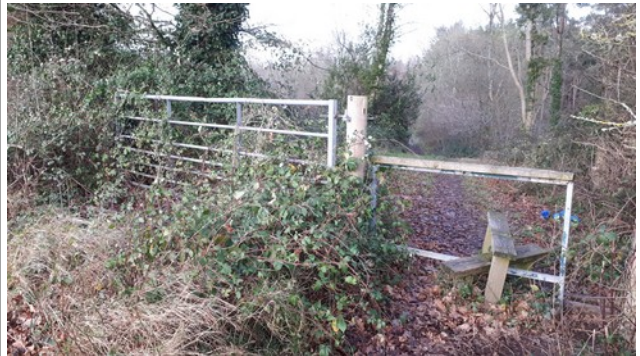
Stile FP1-A comprises a metal frame and wooden steps. It is in a poor condition, and can be walked around.

It is located adjacent to a galvanised metal gate that appears not to have been used in a long time.

The field to the south of FP1-A is not currently used for livestock.

FP1-A seen from the north

FP1-A seen from the south

It is at the end of a track that can be accessed from the road, so it may be prudent to keep the existing gate locked to discourage vehicle access, and replace the stile with a pedestrian-only gate.

Footpath	Item	Suggested action
1	A	Replace dilapidated stile with gate.
	B	Remove unnecessary stile.
	C	Replace stile with gate.
	D	Replace dilapidated stile with gate.
2	A	Remove remains of stile. Do not replace.
3	A	Replace stile with gate
	B	Replace stile with gate
	C	Replace stile with gate
	D	None - existing gate appears satisfactory.
4	A	Replace dilapidated stile with gate
	B	Repair or replace existing kissing gate.
5	A	Remove remains of metal kissing gate. Do not replace.
	B	None - leave existing posts.
6	A	None - existing gate appears satisfactory.
	B	Replace stile with gate.
7	A	Replace stile with gate.
	B	None - existing gate appears satisfactory.
	C	None - existing metal kissing gate appears satisfactory.
	D	None - existing gate appears satisfactory.
9	A	None - existing kissing gate appears satisfactory.
	B	None - existing kissing gate appears satisfactory.
	C	None - existing opening is satisfactory.

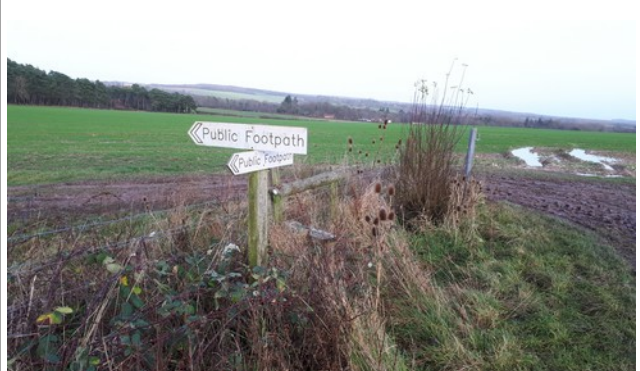
Since a nearby fence was taken out some years ago, it has become possible to walk round the end of the fence where stile FP1-B is located.

This stile appears no longer to be required.

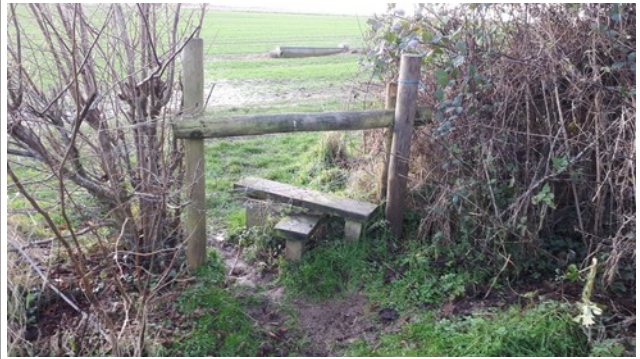
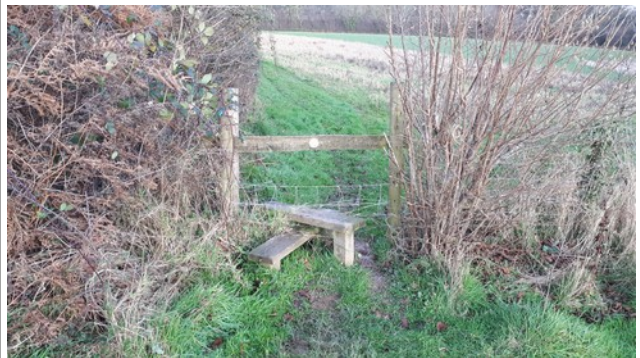
Stile FP1-C is located in a post-and-wire fence. It was replaced a few years ago, when the two posts had rotted at ground level, and is still in reasonably good condition (there is some movement in the steps).

The wire adjacent to the steps has been lifted, presumably to allow dogs and possibly wild animals to pass more easily, and the wear in the grass indicates that this is used quite frequently.

The fields either side of FP1-C are not currently used for livestock.

FP1-C seen from the east

FP1-C seen from the west

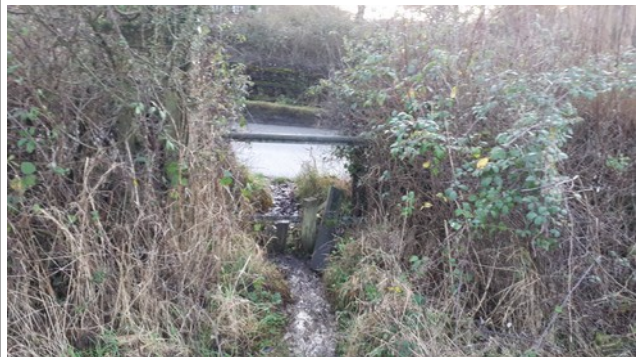
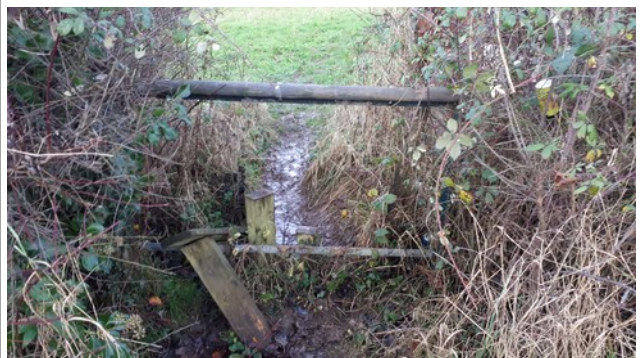
Stile FP1-D comprises a metal frame and wooden steps that have collapsed. The state of repair is clearly poor. Nonetheless, the wear in the vegetation shows that this route is used fairly frequently.

The field is not currently used for livestock.

FP1-D seen from the north

FP1-D seen from the south (road)

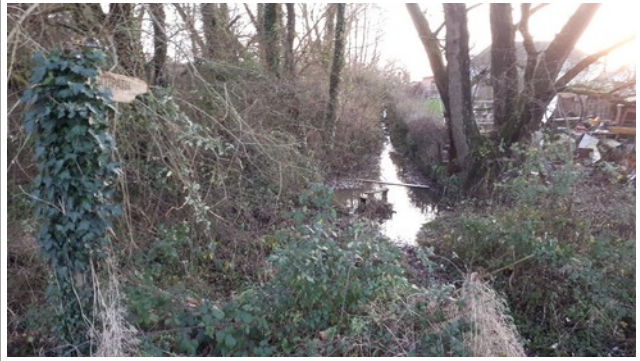
Footpath 2 extends only a few metres from the road before it crosses the parish boundary. The remnants of stile FP2-A can be seen, but the fence it crossed is in disrepair, and has been removed from the immediate vicinity of the stile.

It is not clear on which side of the parish boundary FP2-A lies, but given the current state of the fence, it appears not to be required.

FP2-A seen from the road

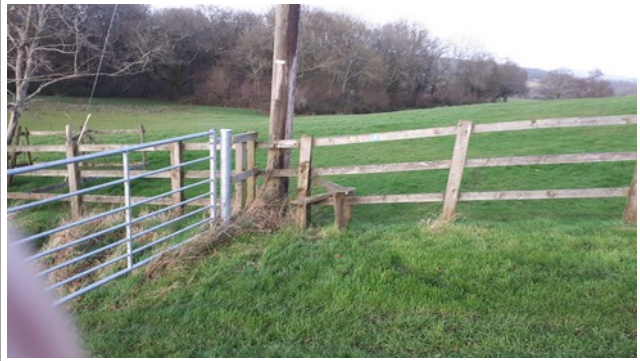
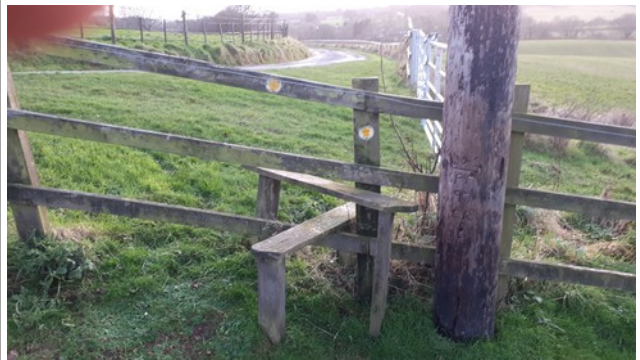
Stile FP3-A is located in a wooden fence, and appears to be in good condition. However, in common with most stiles at this time of year, the surfaces of the steps are quite slippery.

At the time of the visit, the field had no livestock present.

FP3-A seen from the south

FP3-A seen from the north

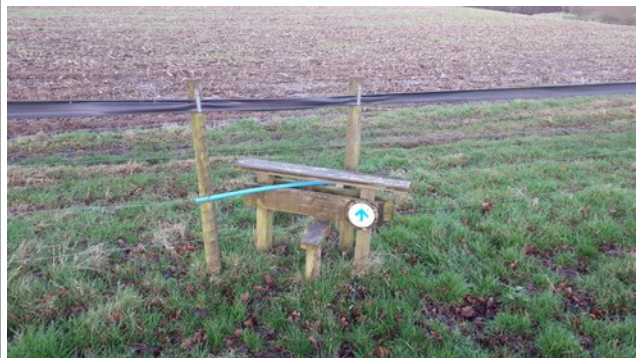
Stile FP3-B crosses a post-and-wire fence between two fields. The field to the south is set to grass, but no livestock were present. The field to the north has recently been used for a crop of maize.

FP3-B seen from the south

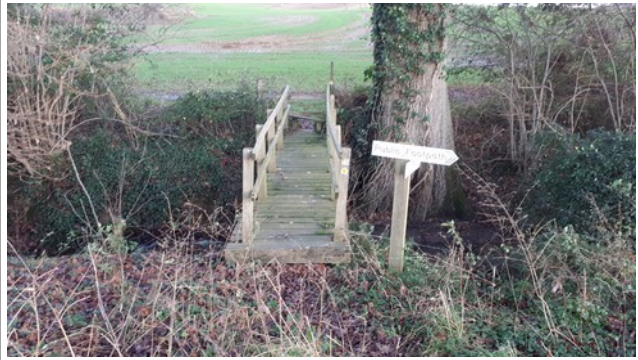
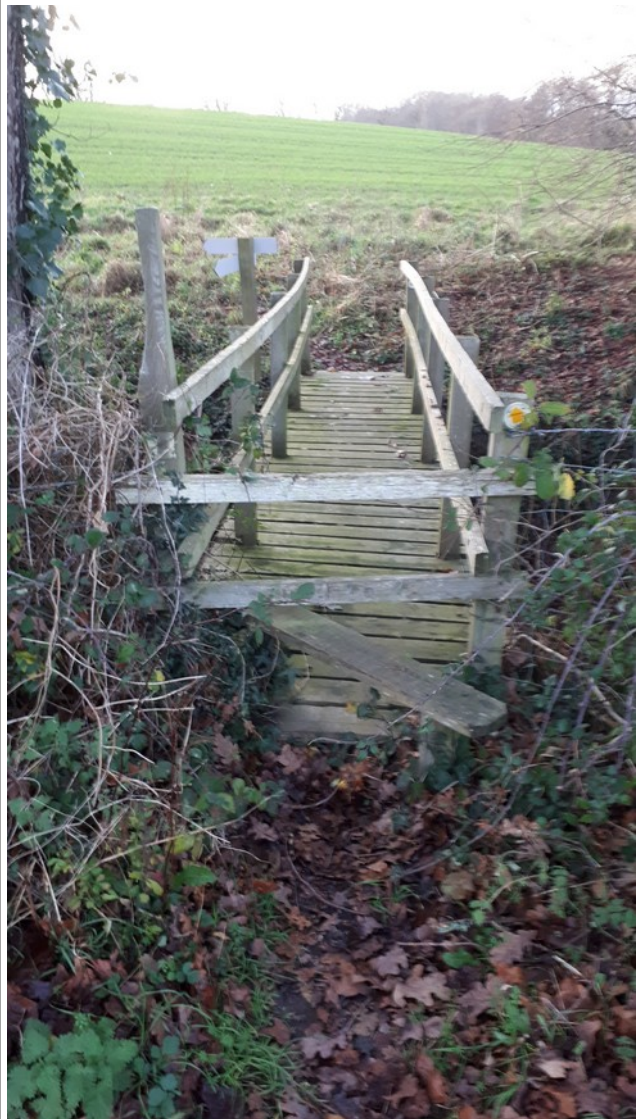
Stile FP3-C is at the eastern end of a footbridge over a small stream. The stile is in fair condition, and has a convenient pillar to assist crossing.

The fields either side of the footbridge appear to be arable; no livestock could be seen.

FP3-C seen from the west

FP3-C seen from the east

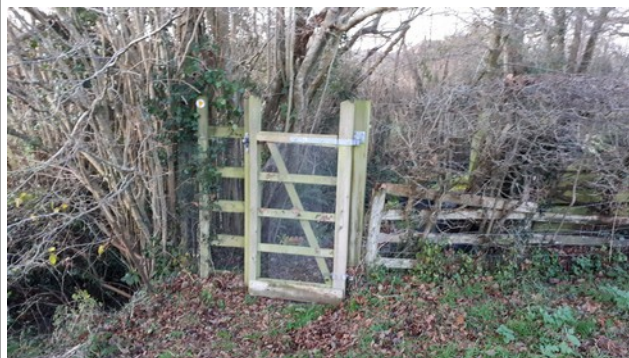
FP3-D

Footpath 3 passes through the garden of a private house, which is entered via the gate FP3-D.

The gate appears to be in good condition.

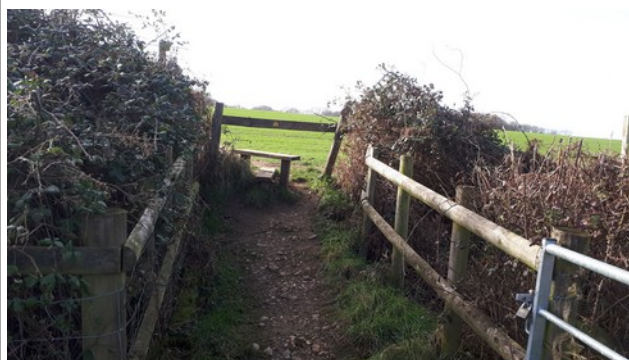
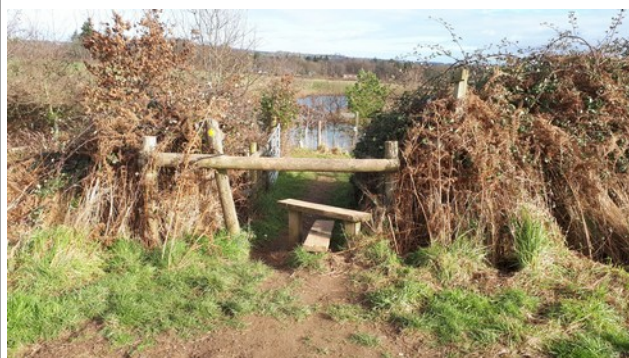
FP4-A is a stile located in a boundary between two fields. The upper field has been used exclusively for crops in recent years, and the lower field has been grassed following the completion of the gravel extraction some years ago. No livestock have been seen in the lower field.

FP4-A seen from the east

FP4-A seen from the west

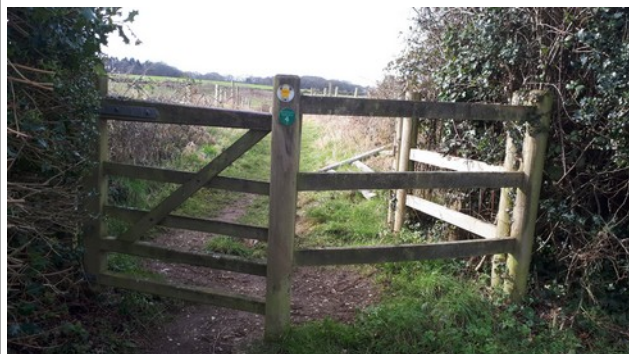
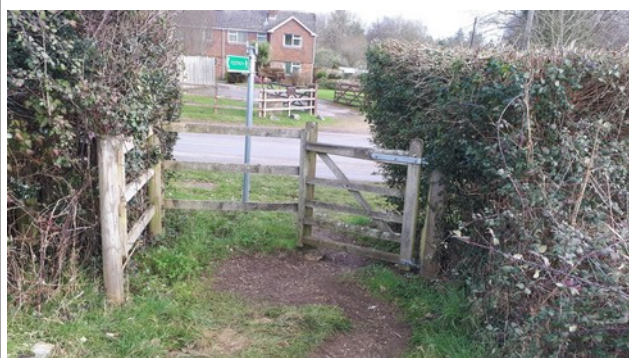
FP4-B is a kissing gate leading from the B3084 into a field where the footpath has been fenced on both sides (note: the fencing, particularly on the south side of the path is in very poor condition, having collapsed due to posts rotting in the ground).

Part of FP4-B has collapsed due to the post rotting in the ground, and can be seen in the upper photograph lying to one side of the path.

FP4-B seen from the road

FP4-B seen from the footpath

As the fence on the north side of the footpath is stock-proof, they may be no need for a kissing gate here; a simple gate may be sufficient.

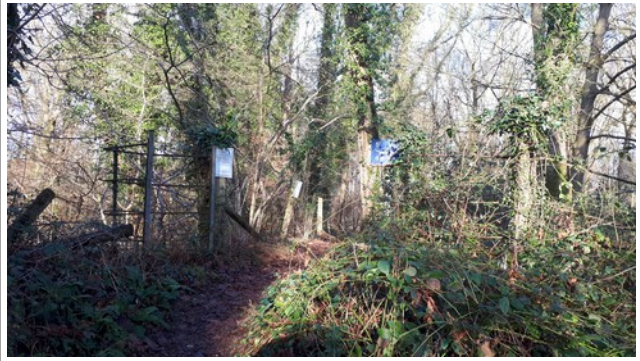
A few metres from the start of the path at the B3084, FP5-A is the remains of a kissing gate that has had the gate removed. It does not block the path, and there seems no need to have any form of gate here.

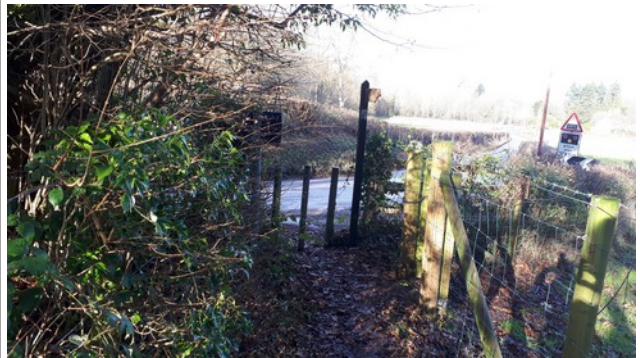
Where the footpath meets Kimbridge Lane, FP5-B is a set of closely spaced sturdy metal posts that have been inserted to block access by all but pedestrians.

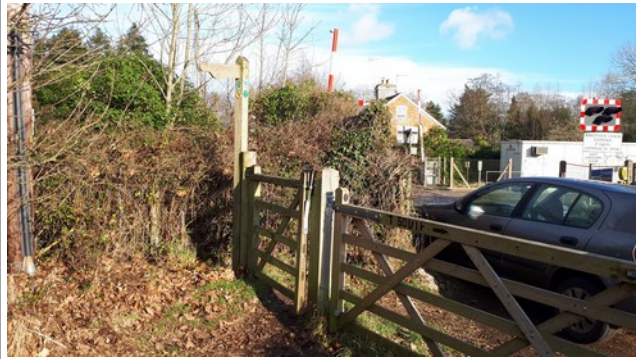
Close to the Kimbridge level crossing, FP6-A is a wooden gate for pedestrian access, next to a wider gate for vehicles and machinery.

The gate appears to be in fairly sound condition.

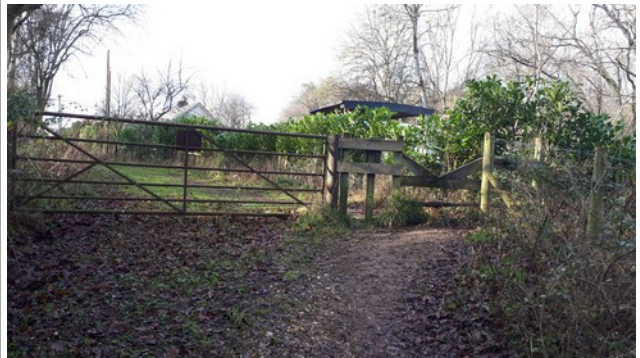
FP6-B is a stile with an adjacent dog gate, next to a wide metal gate for vehicles and machinery.

The stile is in fair condition apart from a missing piece on the dog gate.

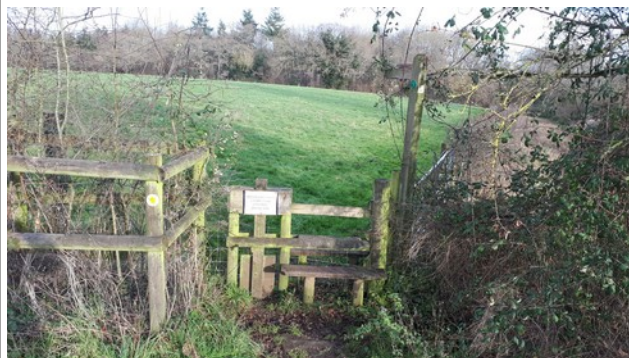
FP7-A is a wooden stile with adjacent dog gate, similar in some respects to FP6-B.

The stile appears to be in fair condition, and unusually has wire netting on the treads to help avoid the surfaces becoming slippery.

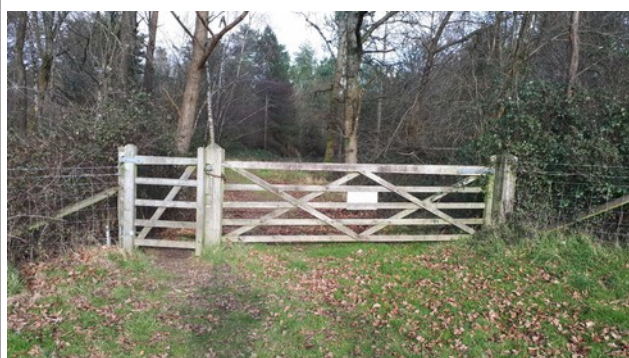
FP7-B is a wooden pedestrian gate next to a wider gate for farm vehicles. The gate appears to be in fair condition.

The gate is on a boundary between woodland and an open grassy field, which is presumably used for grazing, although it was empty at the time of our visit.

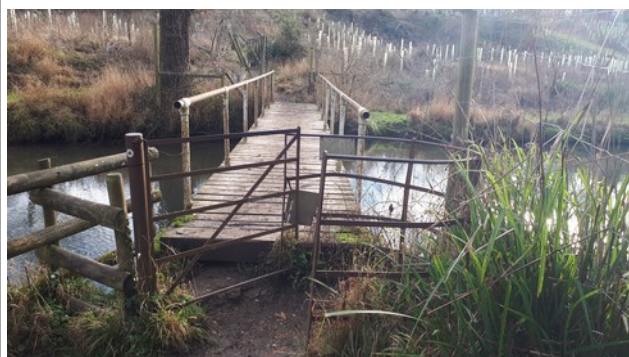
FP7-C is a metal kissing gate at the north end of a footbridge across the river Dun.

The gate appears to be in fair condition.

FP7-C at the north end of the footbridge

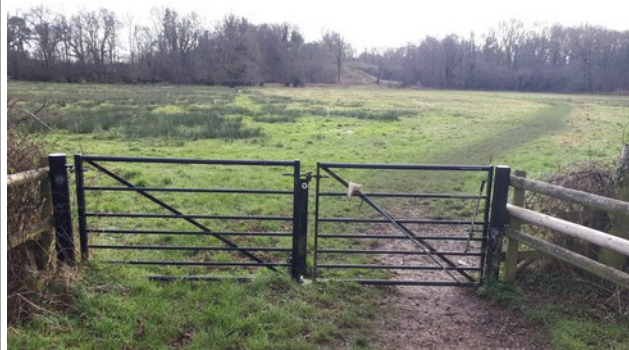
FP7-D is a metal pedestrian gate next to a slightly wider gate in a similar style.

This gate appears to be in good condition.

The field beyond it is believed to be used for grazing, although it was empty at the time of our visit.

FP7-D, view from the north

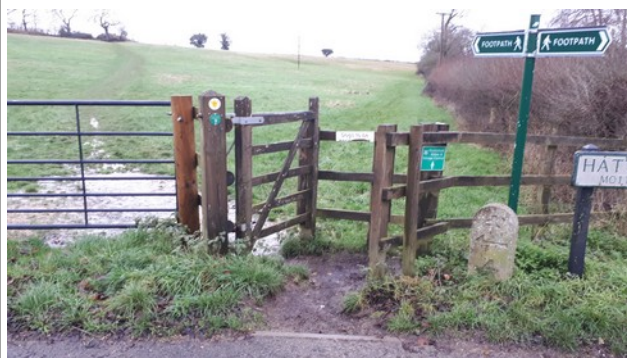
FP9-A is a wooden kissing gate next to a metal gate used for farm vehicle access.

The pedestrian gate appears to be in fair condition.

The field beyond the gate is used for grazing livestock, although it was empty at the time of our visit.

FP9-A, seen from the B3084

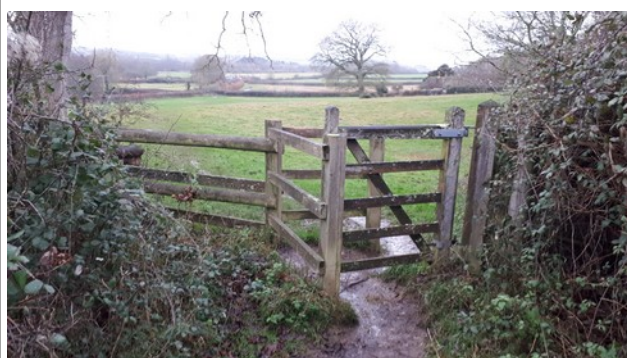
FP9-B is a wooden kissing gate in a boundary fence between two fields

The gate appears to be in fair condition.

The field beyond the gate is used for grazing.
The field this side of the gate is used for crops.

FP9-B, seen from the northeast

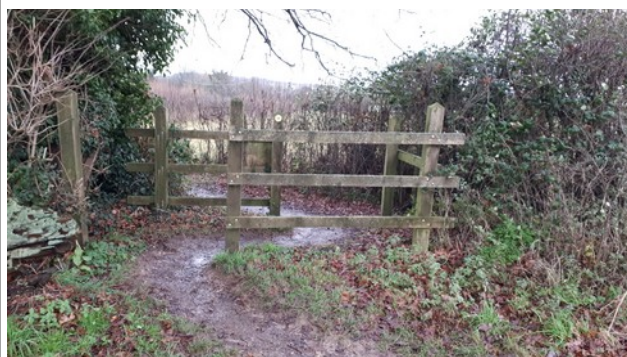
FP9-C is a pair of offset wooden barriers without a gate between them, presumably intended to prevent vehicular access to the field.

FP9-C, seen from the southwest

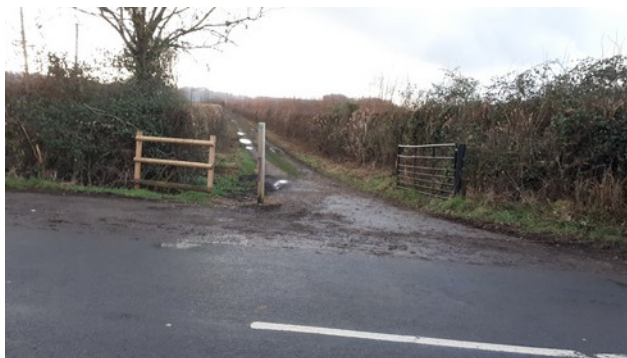
FP10-A, the entrance to footpath 10 from the B3084 is simply an opening adjacent to a metal gate (frequently closed due to fly-tipping).

FP10-A, entrance to footpath 10 from the B3084

10	A	None - existing opening is satisfactory.
	B	None - existing kissing gate appears satisfactory.
	C	None - existing kissing gate appears satisfactory.
	D	None - existing metal kissing gate appears satisfactory.
	E	None - existing wooden gate appears satisfactory.
12	A	None - existing opening is satisfactory.
	B	Replace dilapidated stile with gate.
14	-	None - there are no stiles or gates.
15	A	Replace marker post.
16	A	None - existing opening is satisfactory.
	B	None - existing opening is satisfactory.
18	A	None - existing opening is satisfactory.
	B	None - existing metal gate appears satisfactory.
	C	Replace existing stile with gate.

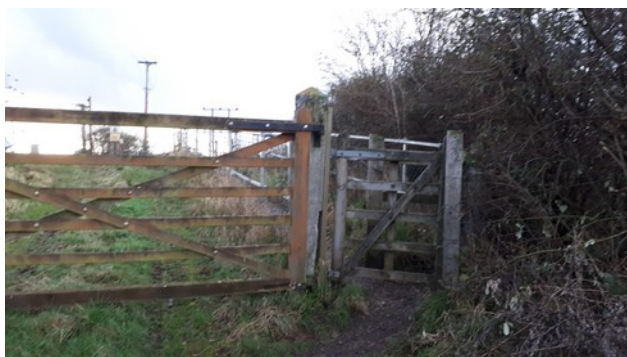
FP10-B is a wooden kissing gate on the east side of the uncontrolled pedestrian crossing for the railway line.

This gate appears to be in fair condition. It is not known at this stage whether this gate is the responsibility of the rail network operator.

FP10-B seen from the east

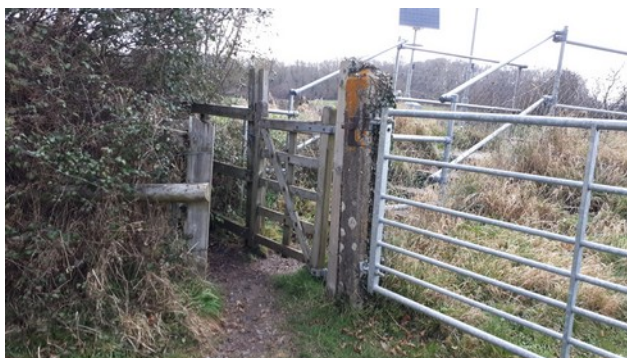
FP10-C is a wooden kissing gate on the west side of the uncontrolled pedestrian crossing for the railway line.

This gate appears to be in fair condition. It is not known at this stage whether this gate is the responsibility of the rail network operator.

FP10-C seen from the west

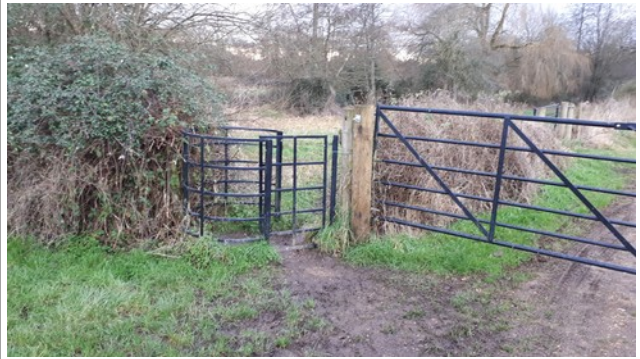
FP10-D is a metal kissing gate located adjacent to the entrance gate to the thatched cottage.

This gate appears to be in good condition.

FP10-D seen from the east

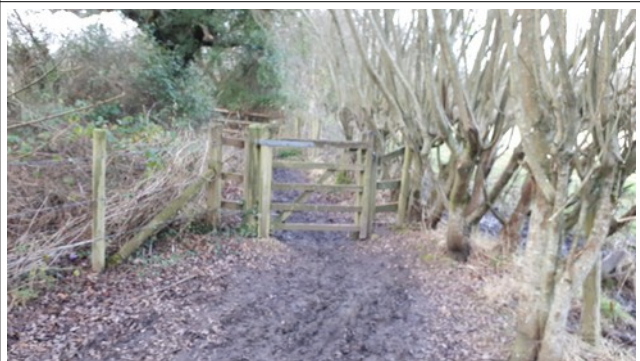
FP10-E is a wooden gate that lies on or close to the parish boundary.

This gate appears to be in fair condition.

Just beyond this gate there are sleepers forming a footbridge crossing a ditch, then a wooden fence with a stile, which is in the adjacent parish. There is presumably therefore no requirement for FP10-E to be stock-proof.

FP10-E seen from the east

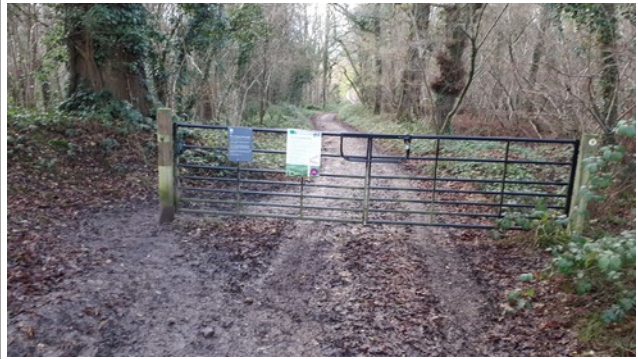
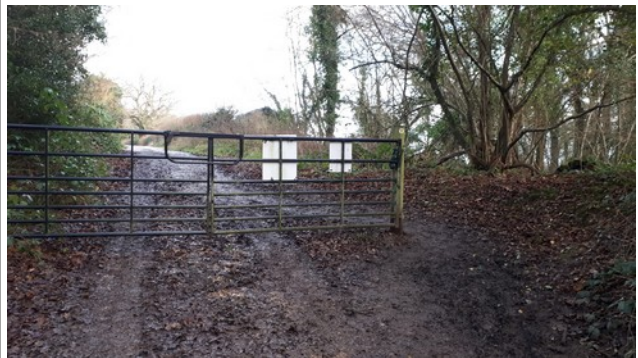
Footpath 12 starts at the junction of Keepers Lane and the B3084. FP12-A is a double metal gate located just beyond the last house on Keepers Lane, with a pedestrian bypass.

FP12-A seen from the east

FP12-A seen from the west

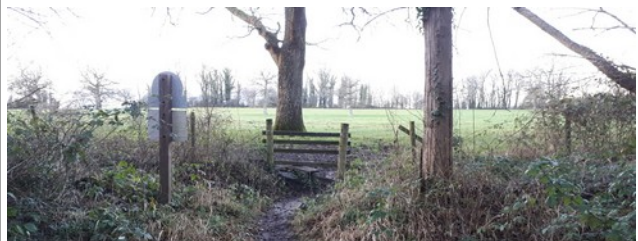
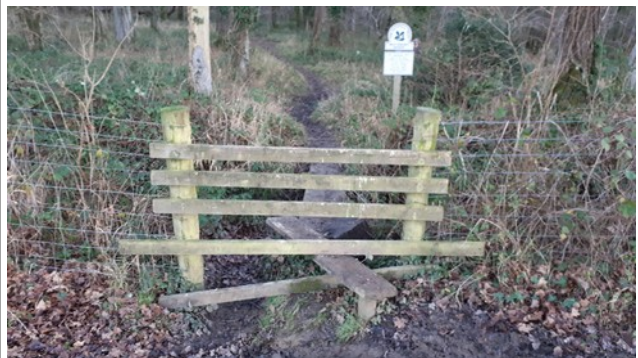
FP12-B is a wooden stile located at the parish boundary, in a fence separating woodland from a grassy field. It is not known whether the field is used for livestock.

This stile is on poor condition, with bottom rail detached at one end.

FP12-B seen from the east

FP12-B seen from the west

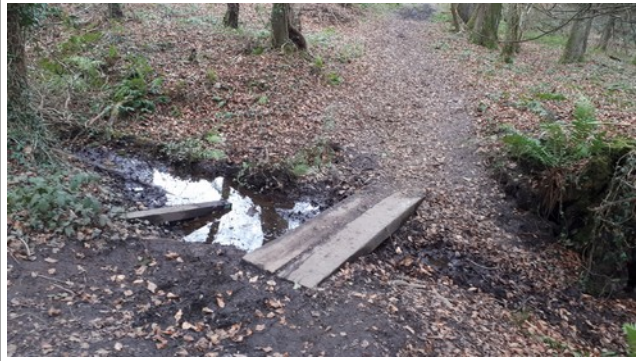
Footpath 15 starts at the parish boundary, which appears to coincide with a small ditch, crossed by a pair of sleepers. The marker post bearing a footpath number label has collapsed into the ditch.

FP15-A seen from the west

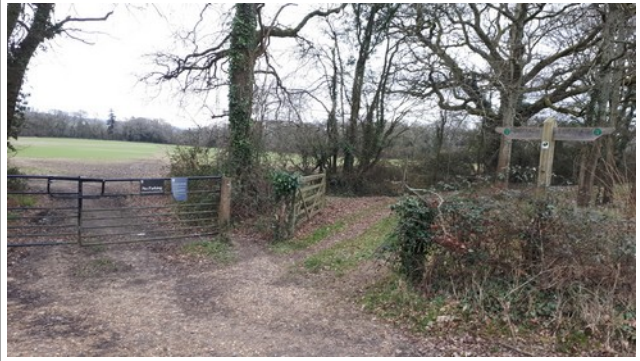
Footpath 16 starts on the B3084. FP16-A is a metal gate with a pedestrian bypass.

FP16-A seen from the B3084

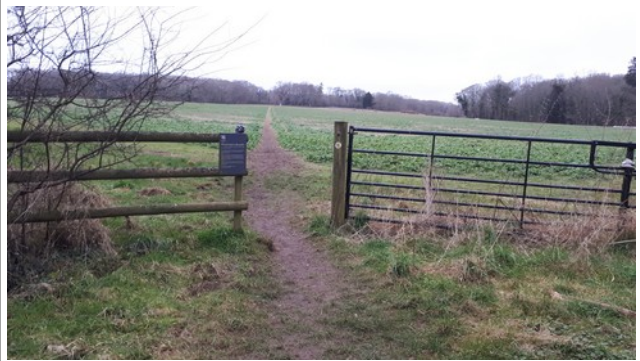
Footpath 16 ends on Bengers Lane, where there is a pedestrian opening adjacent to a double metal gate.

FP16-B seen from Bengers Lane

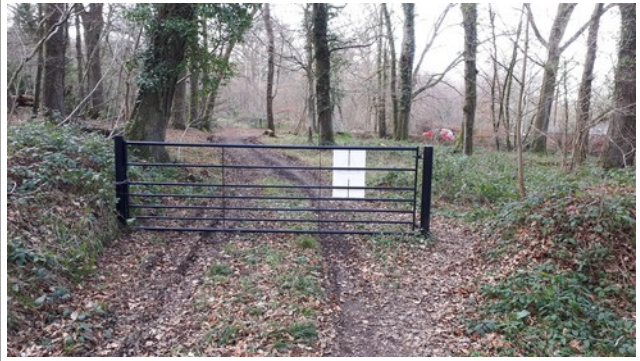
Footpath 18 starts on the B3084. Roughly 50m from the road is FP18-A, a metal gate with a pedestrian bypass.

FP18-A seen from the east

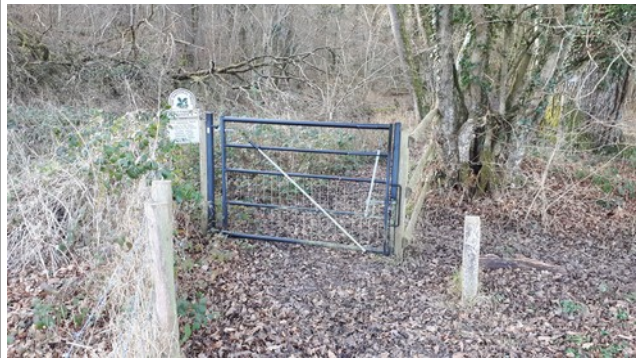
FP18-B is a metal pedestrian gate, located near the edge of woodland.

This gate appears to be in good condition.

FP18-B seen from the east

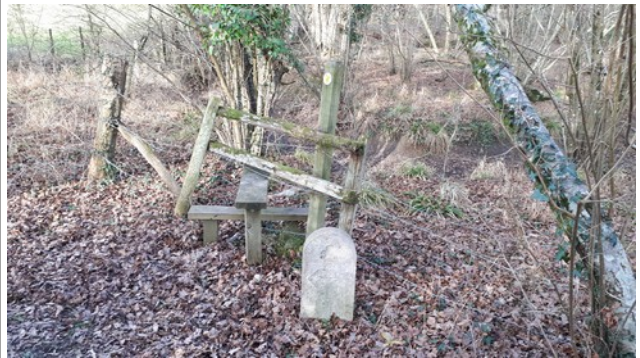
FP18-C is a wooden stile located on a corner of footpath 18, where another footpath (not in the definitive list of rights of way) branches off.

This stile is in poor condition. The steps appear firm, but the posts and rails are loose.

FP18-C seen from the south

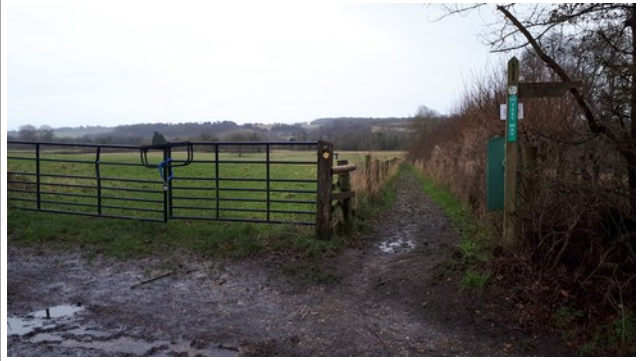
FP19-A is the entrance to the footpath on Oakley Road. This is an open entrance with no gate or stile.

FP19-A, seen from the west

19	A	None - existing opening is satisfactory.
	B	None - existing opening is satisfactory.
20	-	None - there are no stiles or gates.
21	A	Replace dilapidated stile with gate.
	B	Replace stile with gate.
22	-	None - no gates or stiles found on overgrown path.
705	A	Replace low static barrier at end of bridge with a gate.

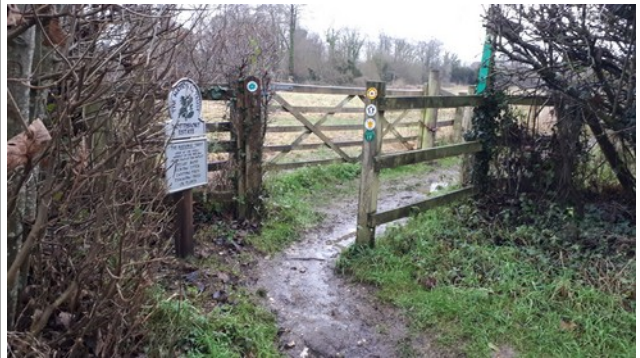
FP19-B is the open entrance to the footpath on Oakley Lane. This is an open entrance with no gate or stile.

FP19-B, seen from the north

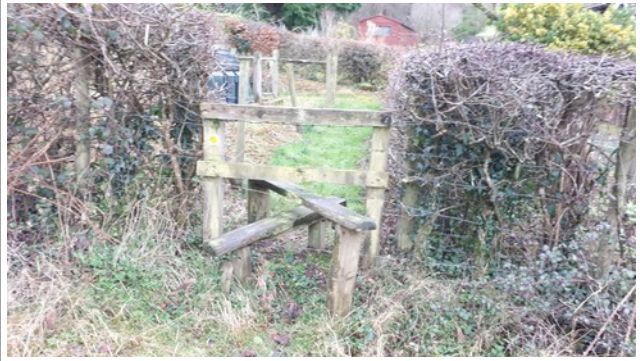
FP21-A is a wooden stile in a mixed hedge.

The condition of the stile appears to be poor.

FP21-A, seen from the north

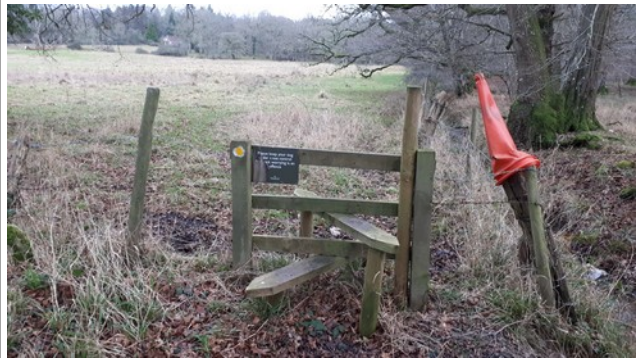
FP21-B is a wooden stile in a post and wire fence.

The condition of the stile appears to be fair.

FP21-B, seen from the north

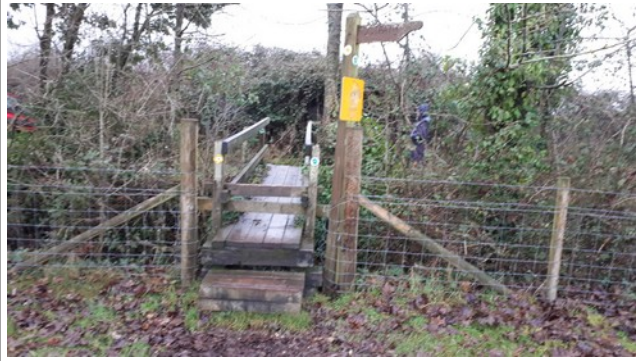
FP705-A is a simple low fixed barrier at the east end of a pedestrian bridge over a small stream.

FP705-A, seen from the east
