FOOTPATHS IN MOTTISFONT PARISH

Mottisfont Parish Council is investigating replacement of stiles on the public footpaths across the parish. The objective of such a project would be to improve accessibility by removing unnecessary stiles, or replacing stiles with suitable gates. This would have the additional advantage of removing stiles that are unsafe.

This report shows the routes of all registered footpaths in the parish, and identifies stiles and gates that have been found on those footpaths. It also suggests actions at each location.

Prepared by
Julia Barnett and Peter Barnett
February 2022

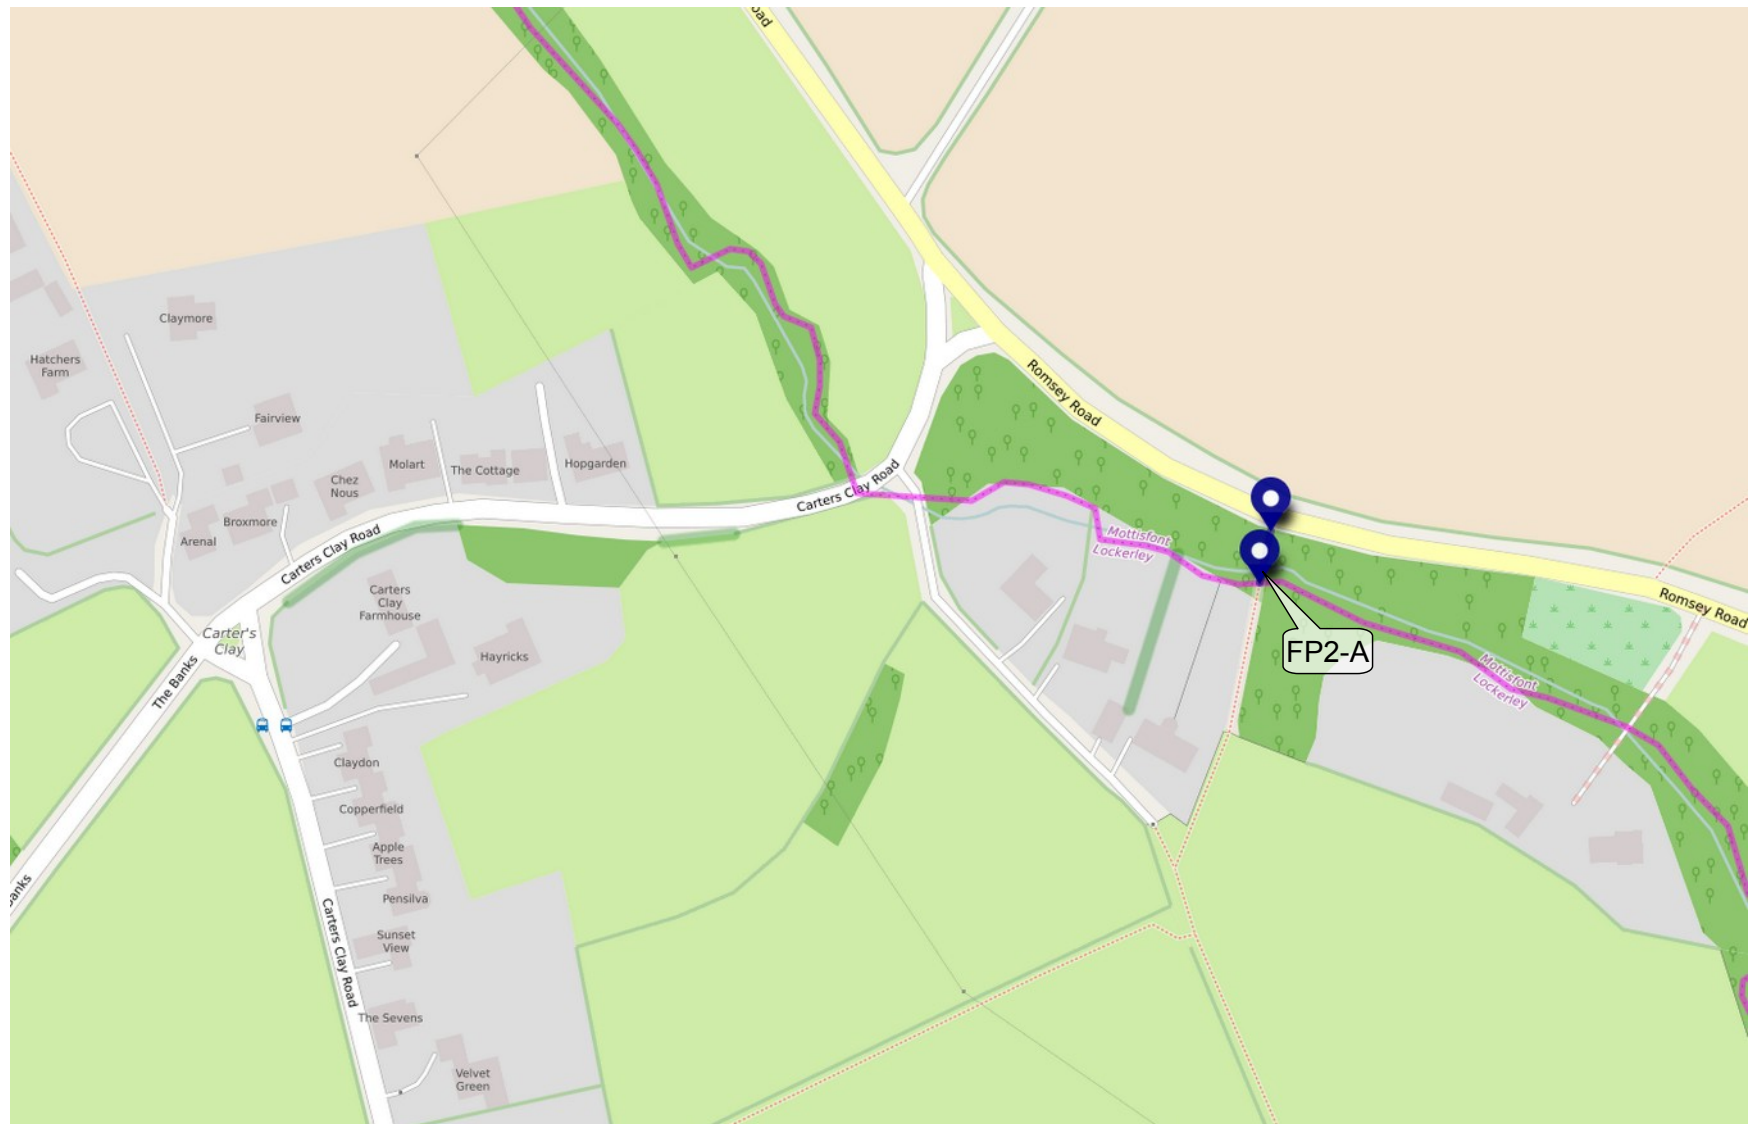
Mottisfont Footpath 2

Footpath 2 extends only a few metres from the road before it crosses the parish boundary. The remnants of stile FP2-A can be seen, but the fence it crossed is in disrepair, and has been removed from the immediate vicinity of the stile.

It is not clear on which side of the parish boundary FP2-A lies, but given the current state of the fence, it appears not to be required.

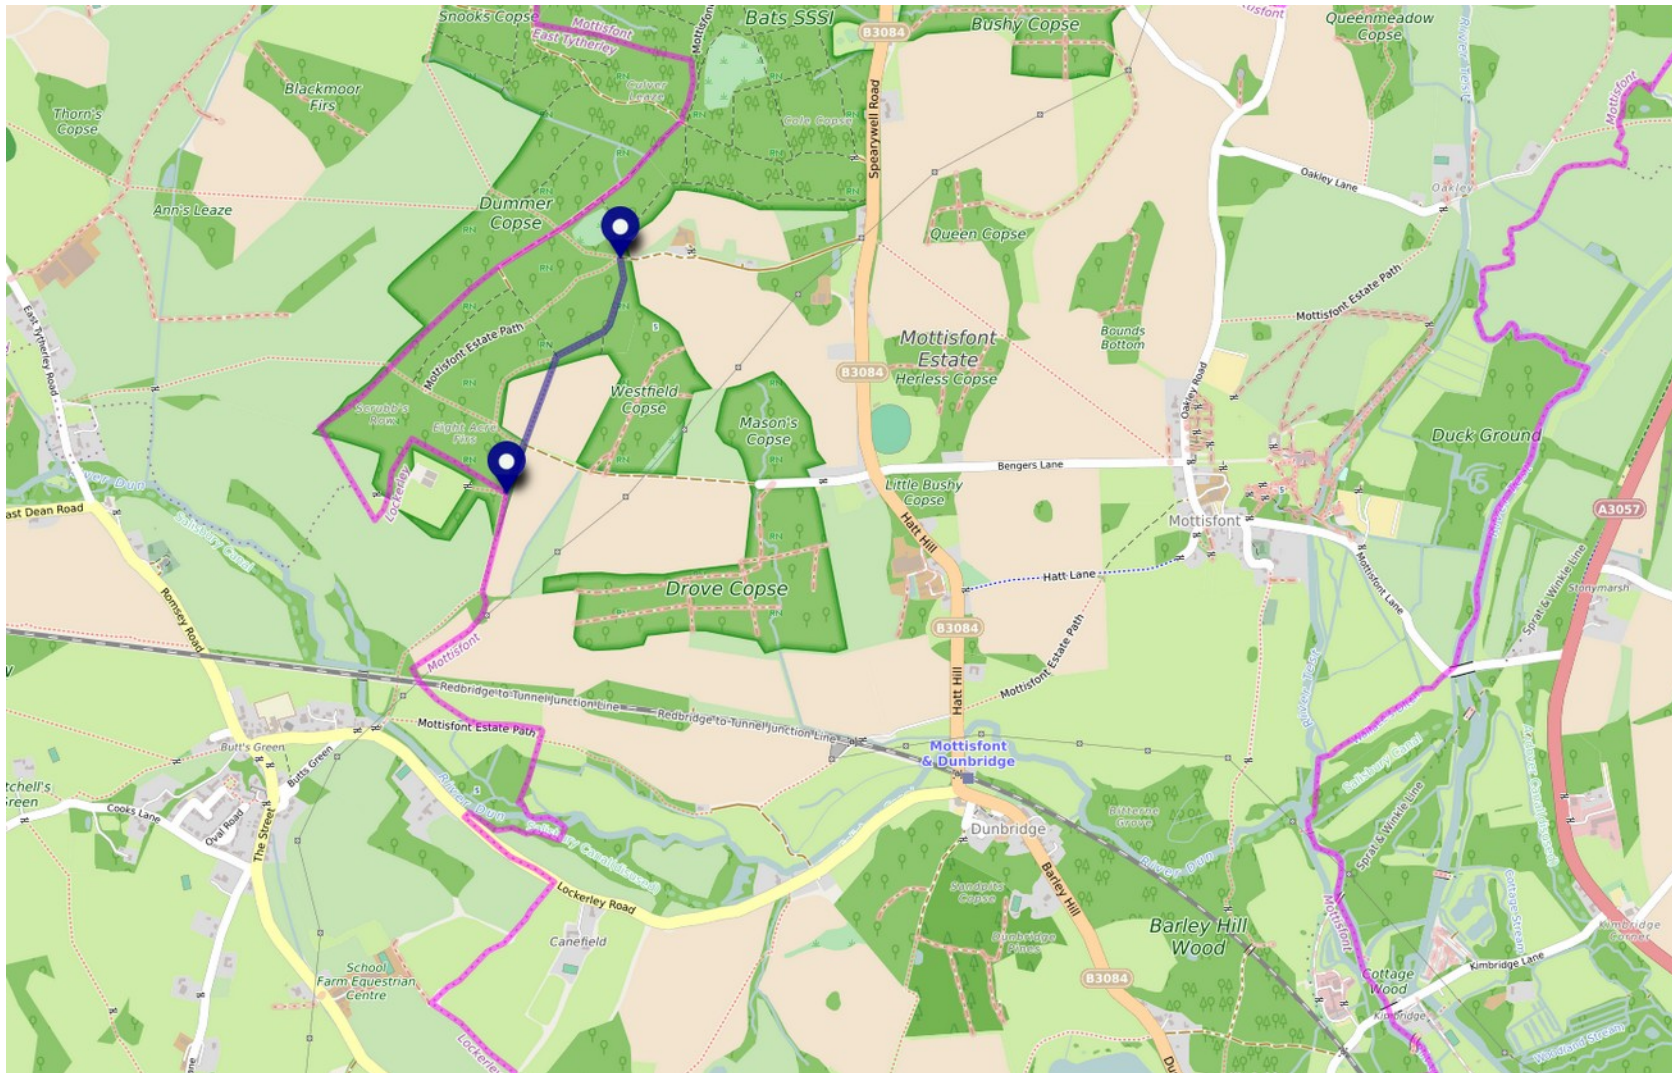
Mottisfont Footpath 14	
No stiles or gates were found on Footpath 14.

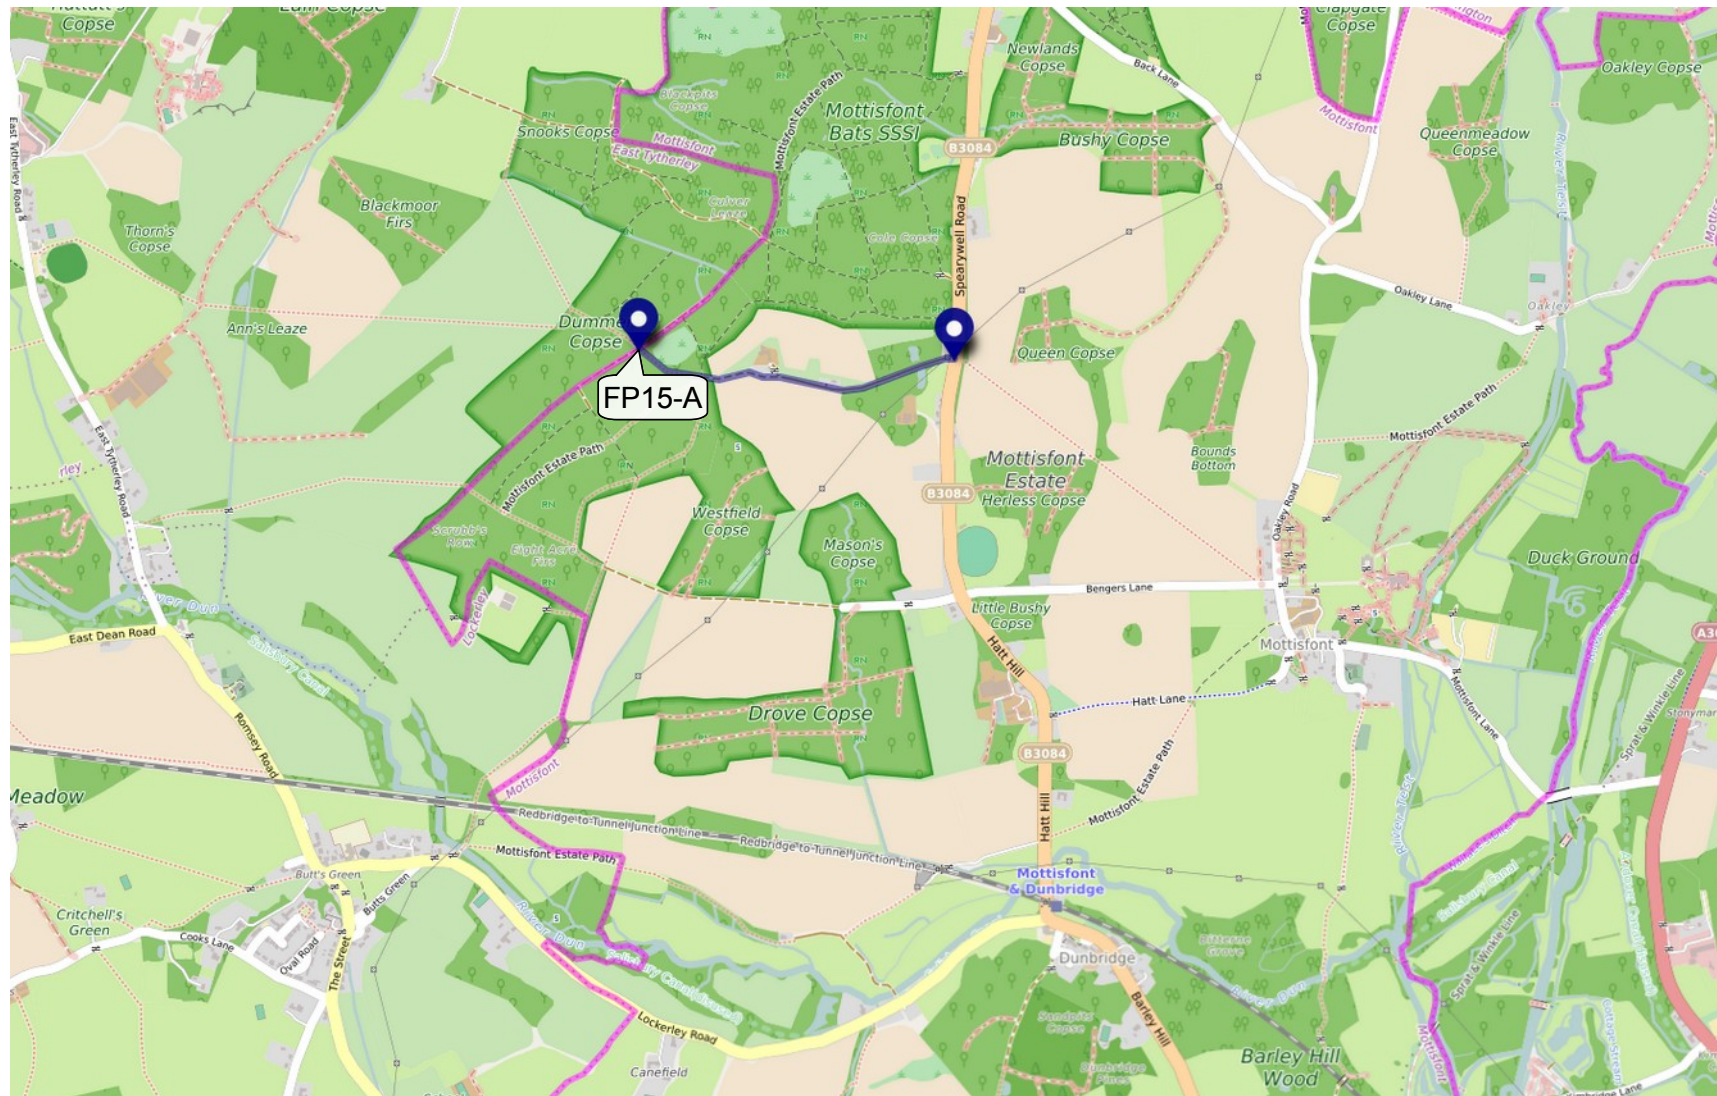
Mottisfont Footpath 15

Footpath 15 starts at the parish boundary, which appears to coincide with a small ditch, crossed by a pair of sleepers. The marker post bearing a footpath number label has collapsed into the ditch.

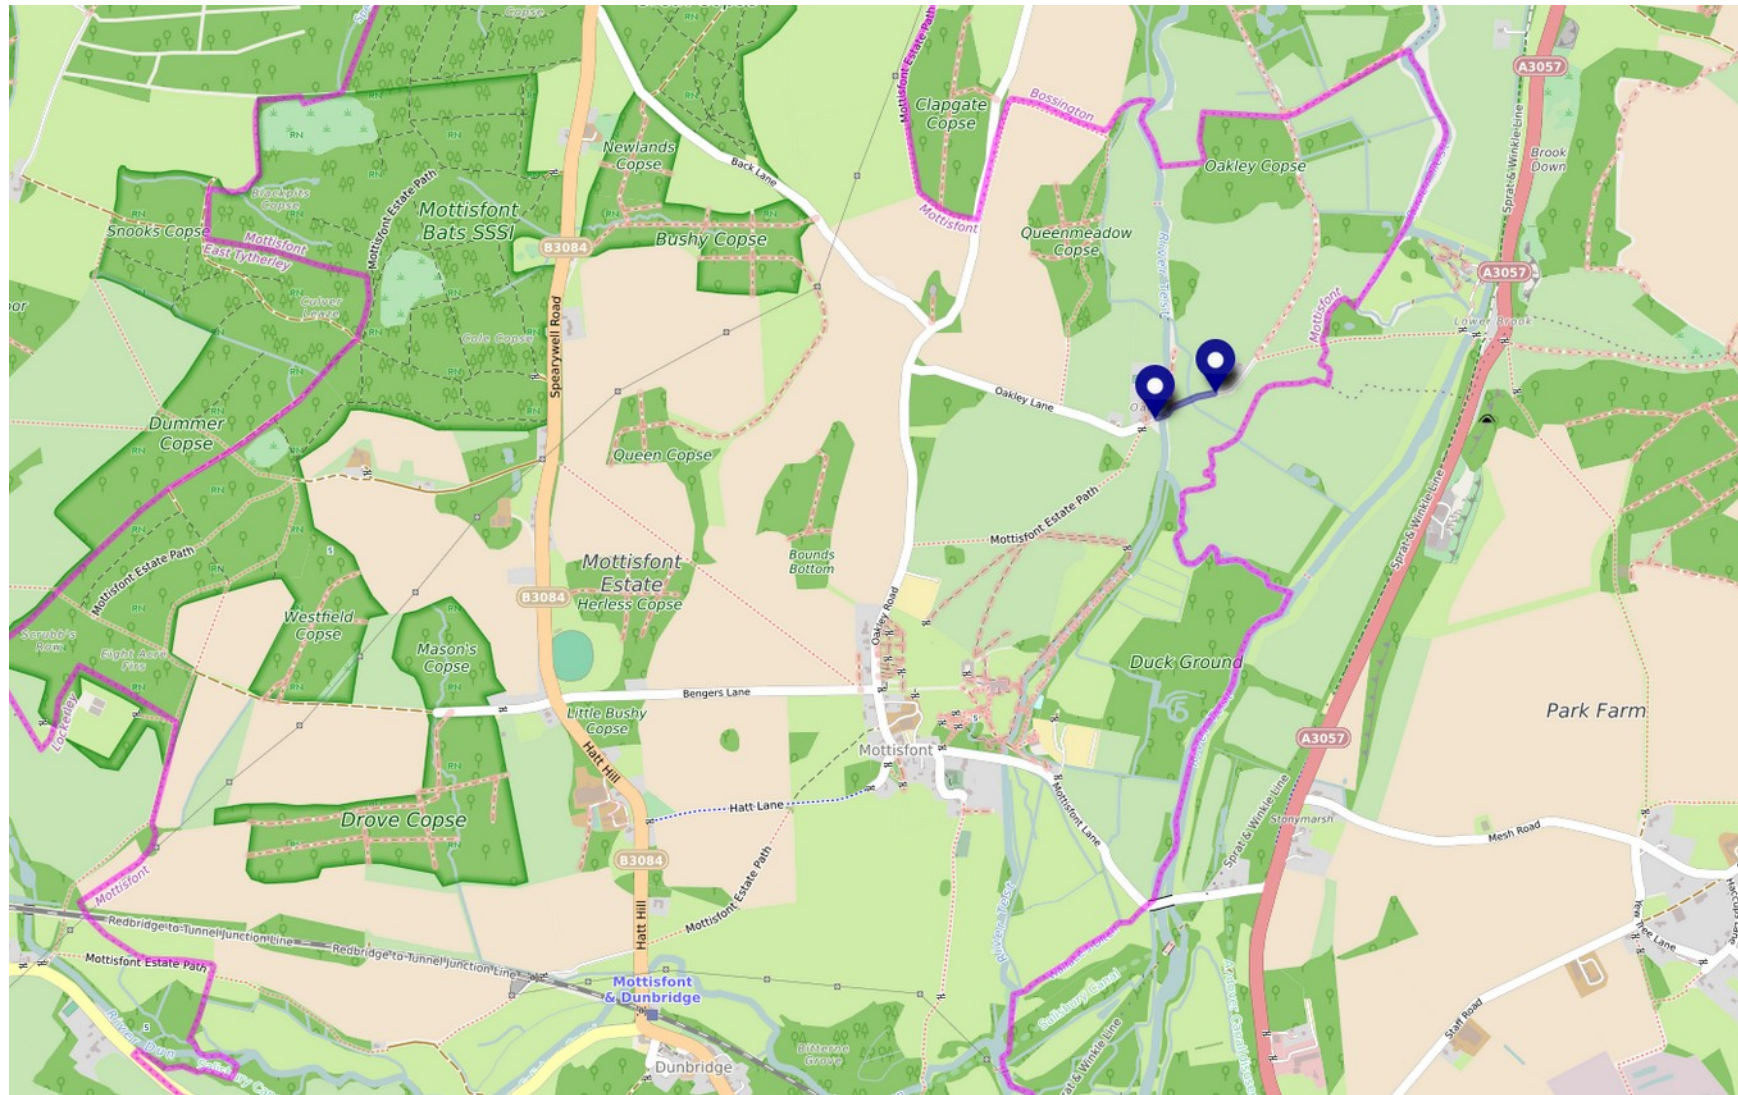
Mottisfont Footpath 20
Footpath 20 is on a gravel road, and has no gates.

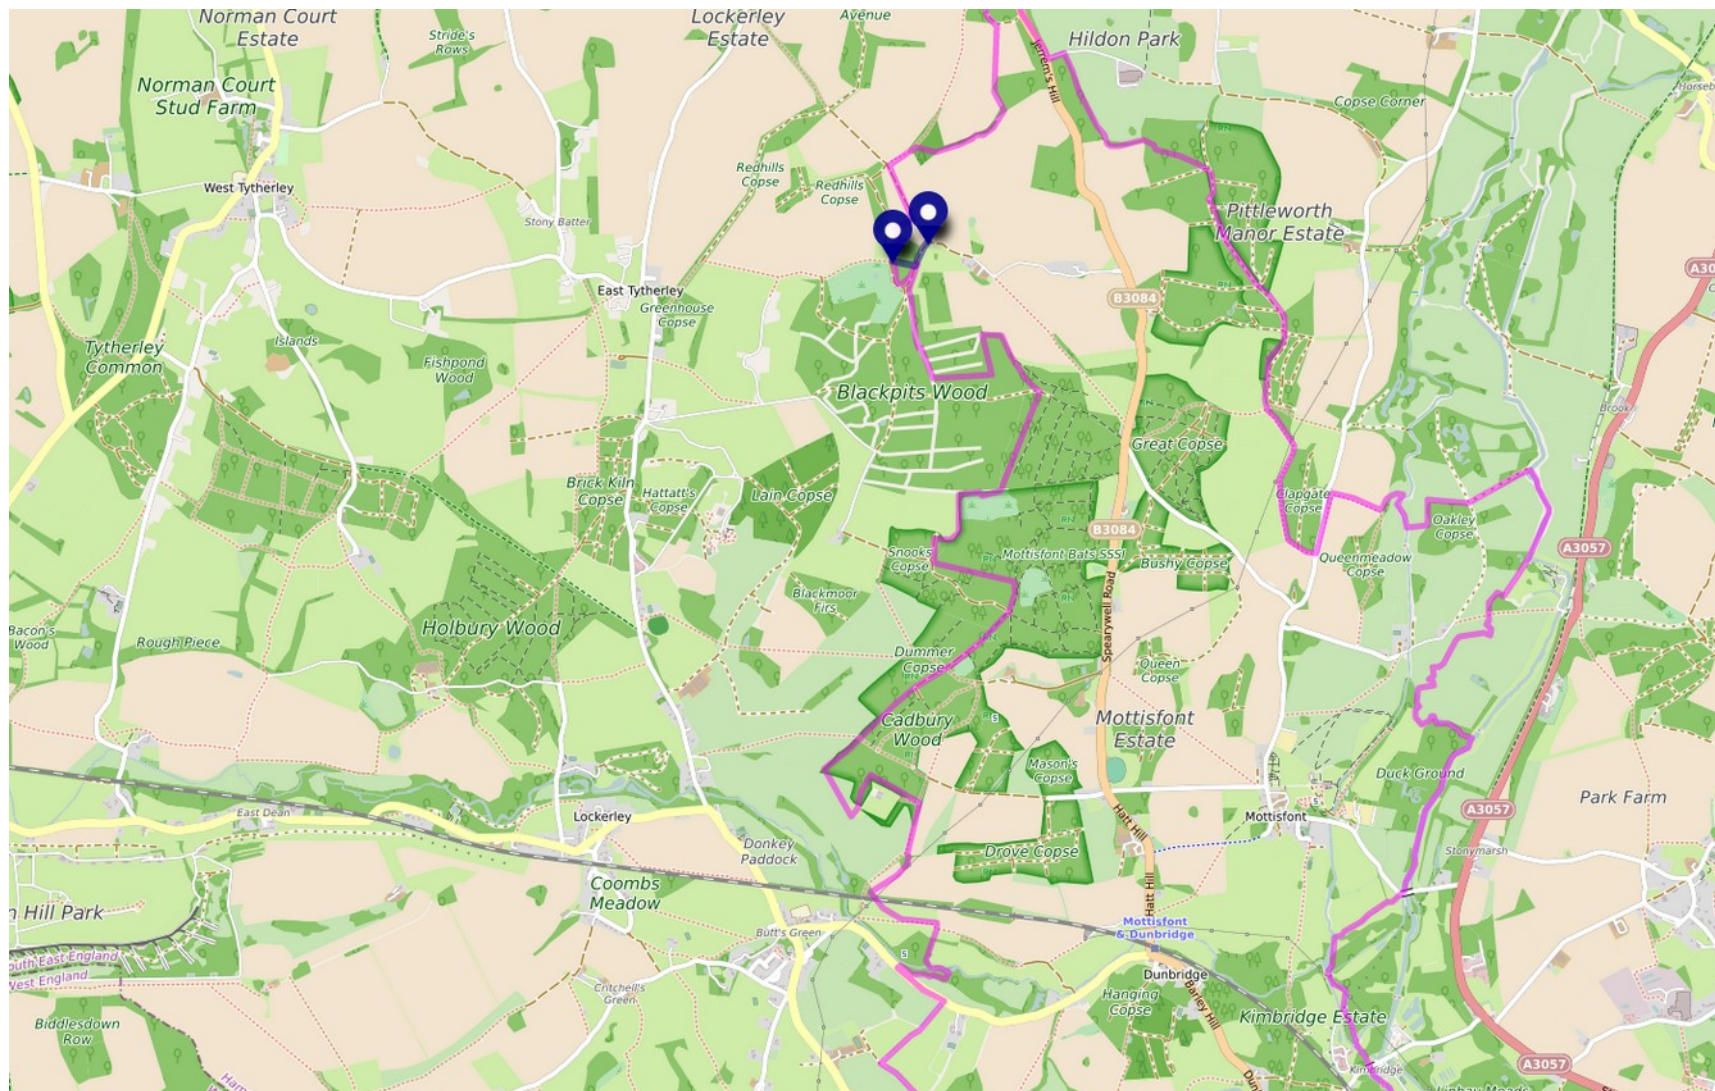
Mottisfont Footpath 22

The footpath starts on a gravel track and heads roughly south until it turns right into woodland. The path through the woodland could not be identified, and is presumably overgrown. No relevant stiles or gates were seen.

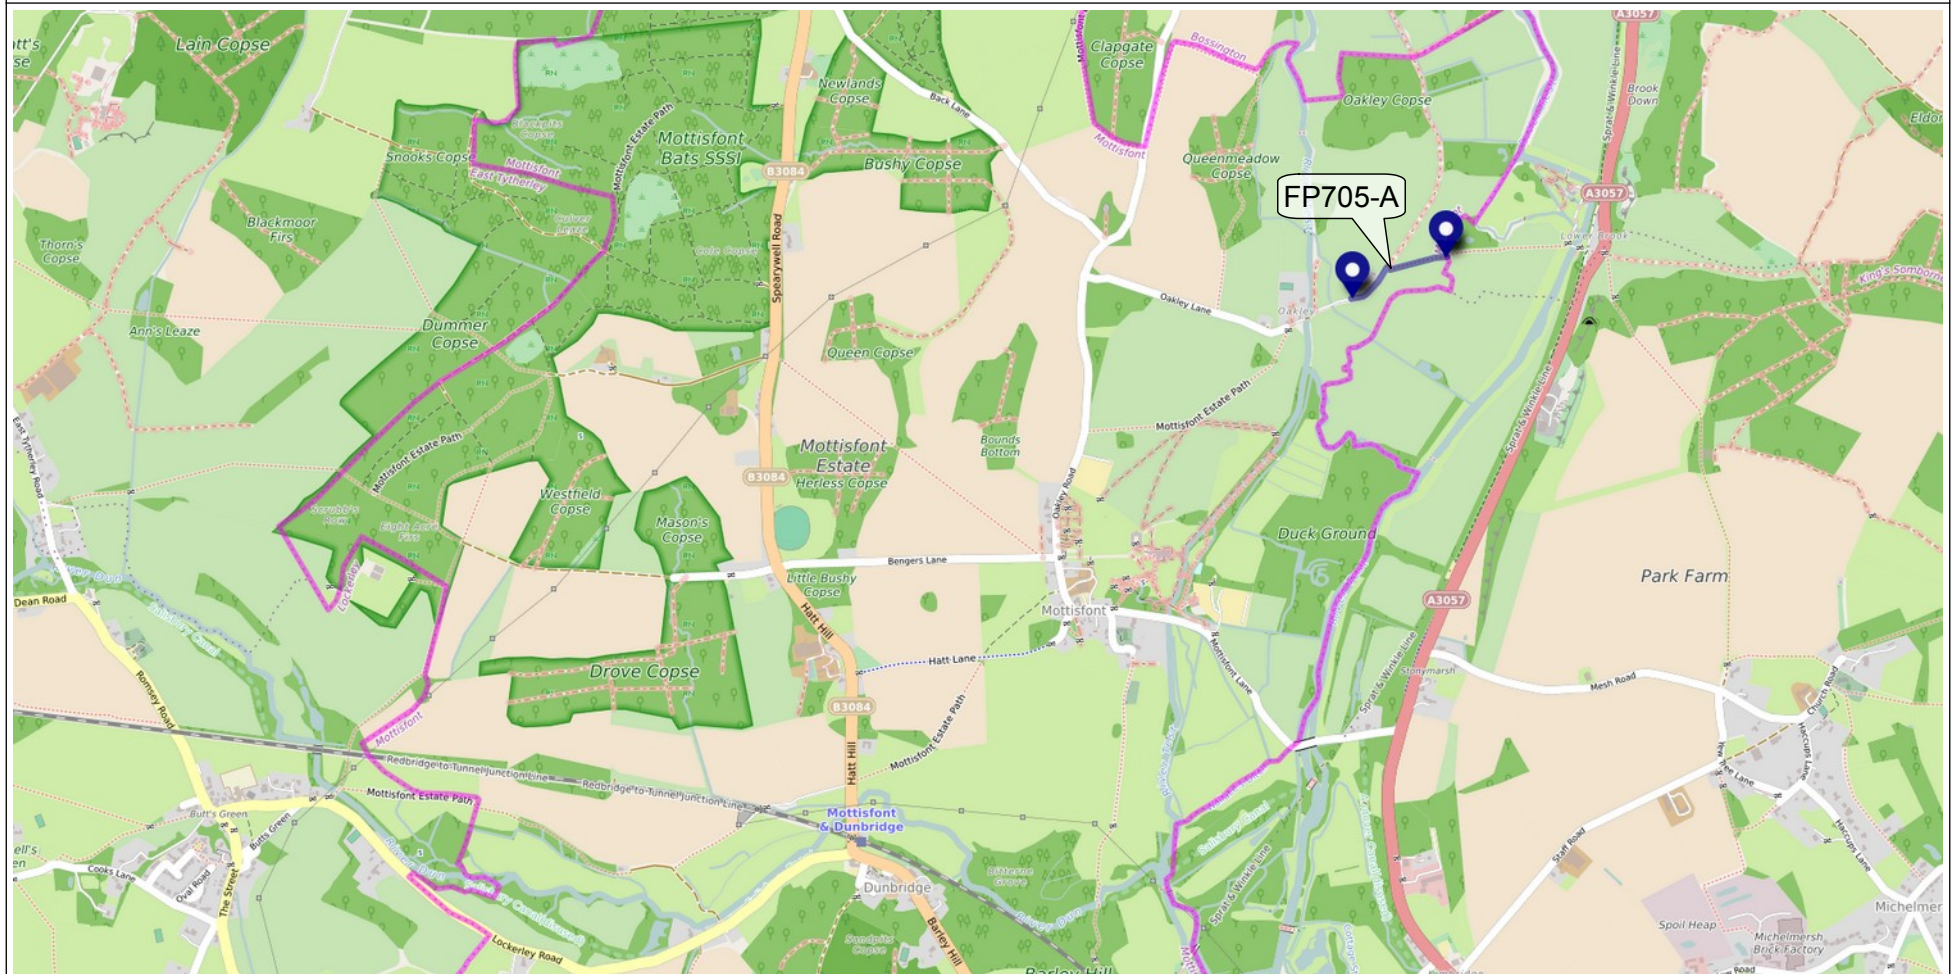
Mottisfont Footpath 705

FP705-A is a simple low fixed barrier at the east end of a pedestrian bridge over a small stream.
